AMRL-TR-77-60

F/FB-111 ESCAPE INJURY MECHANISM ASSESSMENT

LEON E. KAZARIAN

OCTOBER 1977

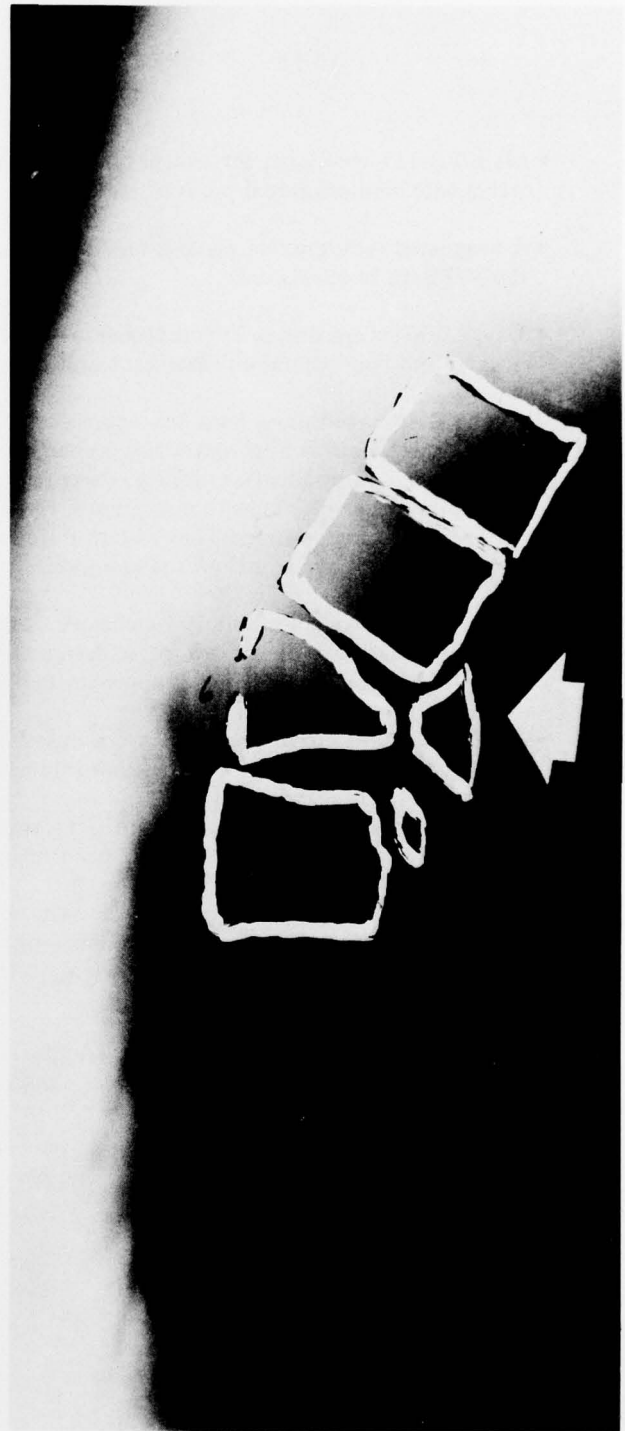
Figure 38. Lateral Roentgenogram of Subject TI 64 Weeks After Ejection [Bony Fusion is Noted to be Occurring]

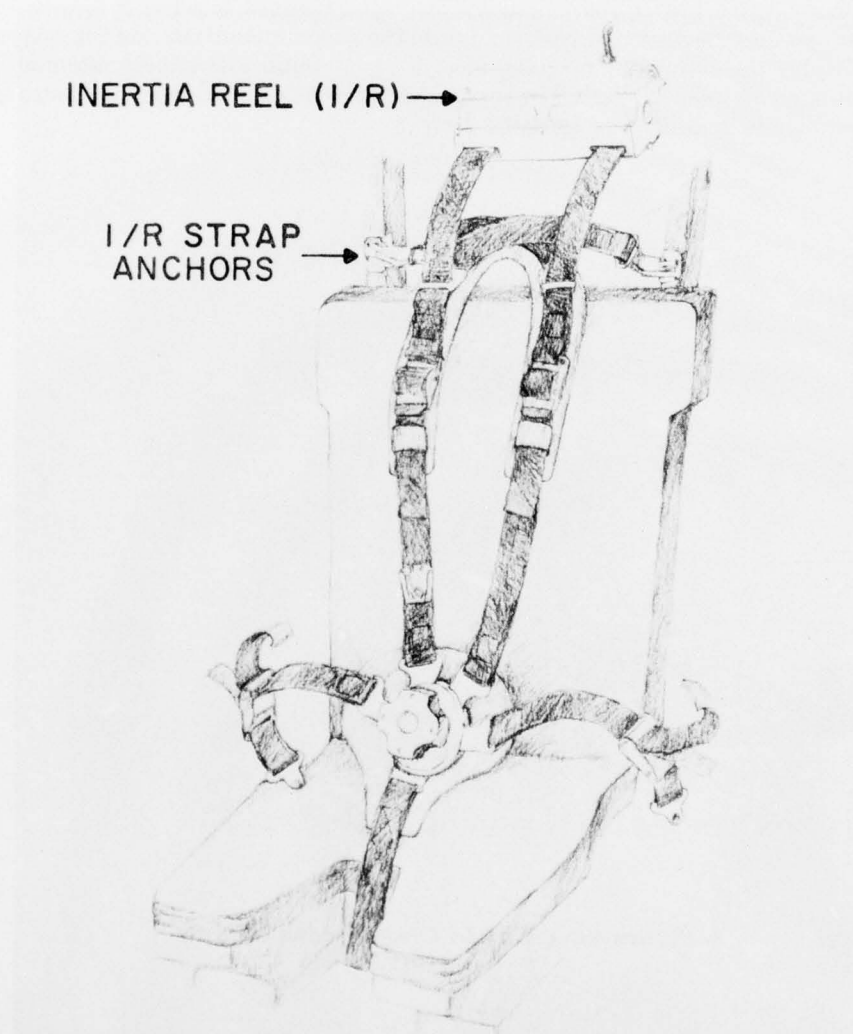
The F/FB-111 seat moves up and down electrically for a total span of 5 inches, and the seat pan moves fore and aft manually through five stops, which are approximately one inch apart. As the seat pan moves forward, the angle formed by the seat back and seat pan becomes obtuse; hence, the torso of the aircrewman moves away from the vertical, and as a consequence the angle formed between the aircrewman's shoulder and the fixed inertia reel take-up decreases. On the other hand, if the seat pan is moved back, toward the vertical position, the angle formed by the aircrewman's shoulder and the place of action of the inertia reel increases. Moving the seat up increases the angle, and moving the seat down decreases the angle. The significance of this motion is related to the positioning of an aircrewman with respect to the angle of action (pull) of the powered inertia reel and the potential for hyperextension injury.

Figure 43. The Support and Restraint System Showing Position of the Inertia Reel and the Strap Anchors

The seat back of the F/FB-111 is 22.25 inches in length. The anchors for the inertia reel are mechanically set at 23.5 inches above the seat pan. An aircrewman who has a shoulder height of 23.5 inches or more is automatically sitting above the level of the inertia reel anchor points regardless of seat position. The shoulder height of the 95th, 50th, and 4th percentile crewmen are 27.3, 25.4 and 23.5 inches, respectively. The seat headrest structure is attached to the aft bulkhead, and the headrest has seven fore and aft adjustments for movement. As the headrest moves forward, the seat back pivots forward.

If the position and/or the geometry of the inertia reel and the shoulder strap anchor points are raised upwards above a crewman's shoulders, both injury modes will be significantly reduced. At the time of this writing, a statement of work has been written, and a program will be started in August 1977 to correct the design deficiencies in the support and restraint system that will significantly reduce the back injury problem.
